# Standard Operating Procedure

| Document Ver.: A/O | | | Document No.: ED20260903 | | | Date Created: September 3, 2026 | | | Revision Date: | | | | | | | |
| Product Name | | | | KENKO-Pieni III | | | | Process No. | K-01 | Process | Disassembly | Time | 15S | Page 1 | Date | 2026.09.03 |

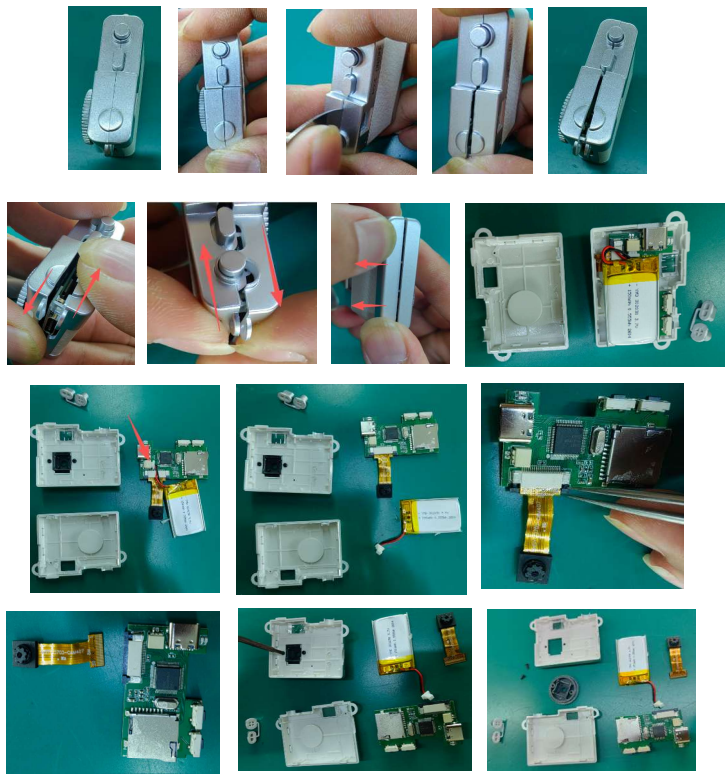
| No. | Parts Model No. | Part Name | QTY | 2. Place the bare unit on the workbench (see Fig. 1). Apply force from both ends toward the center to create a gap (see Fig. 2). | | | | | | | | | | | | |
| | | | | 3. Insert the spudger into the joint between the upper and lower covers (see Fig. 3). | | | | | | | | | | | | |
| | | | | 4. Insert the spudger and release the clips at the upper-right corner of the upper and lower covers (see Figs. 4 and 5). | | | | | | | | | | | | |
| | | | | 5. As shown in Fig. 6, firmly hold the upper cover with your left hand and pull it in the direction of the arrow. Hold the lower cover with your right hand and pull it in the same direction.<br>* Apply force gradually; do not pull forcibly. | | | | | | | | | | | | |
| | | | | 6. Once the clip at the upper-right corner shown in Fig. 6 is completely released, pull the upper and lower covers in the direction of the arrows as shown in Fig. 7 to release the clips around the button. | | | | | | | | | | | | |
| | | | | 7. As shown in Fig. 8, pull the lower cover downward in the direction of the arrow to release the clips securing the upper and lower covers (see Fig. 9). | | | | | | | | | | | | |
| | | | | 8. Remove the button and PCBA as shown in Fig. 10. | | | | | | | | | | | | |
| | | | | 9. After removing the main PCB, the battery will be visible. Disconnect the connector from the main PCB and completely separate the battery from the main unit (see Fig. 11). | | | | | | | | | | | | |
| | | | | 10. As shown in Fig. 12, release the locks at both ends of the camera connector by moving them horizontally, then remove the camera (see Fig. 13). | | | | | | | | | | | | |
| | | | | 11. As shown in Fig. 14, use a screwdriver to remove the screw securing the gear, then remove the gear (see Fig. 15). | | | | | | | | | | | | |

| | | | | 1. Do not remove the covers by force. If the clips at the upper-left and upper-right corners and the lower-left and lower-right sides of the upper cover (four locations in total) are damaged, the clips may become loose and cause the gap to | | | | | | | | | | | | |
| | | | | 2. During disassembly, position the spudger accurately and avoid rubbing it against other areas, which may damage the cover. | | | | | | | | | | | | |
| | | | | 3. The above describes the detailed disassembly procedure. (*The operations shown in Figs. 6, 7, and 8 can be performed simultaneously.) | | | | | | | | | | | | |
